Manhole Inspection Summary

Manhole # S69S__016MH

Location Address: **6513 Danville Ave.**

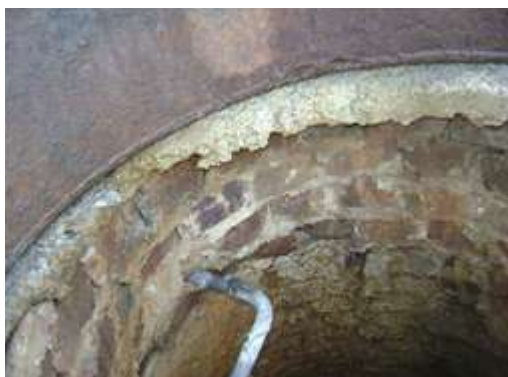
Defect 6

Condition: ☐ Sound ☐ Cracked ☐ Root Intrusion ☒ **Loose Brick** ☒ **Deteriorated**

Deterioration around frame/chimney

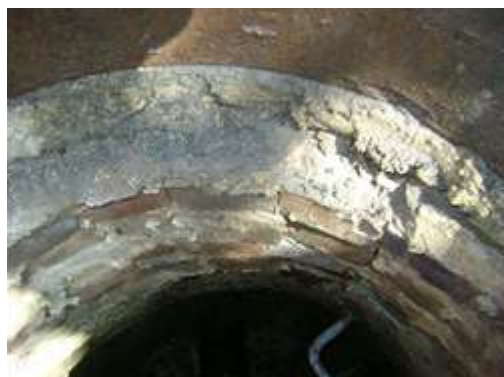
Defect 2

Frame Offset: **3** (in.) Condition: ☐ Sound ☒ **Cracked** ☐ Leaks

Offset frame

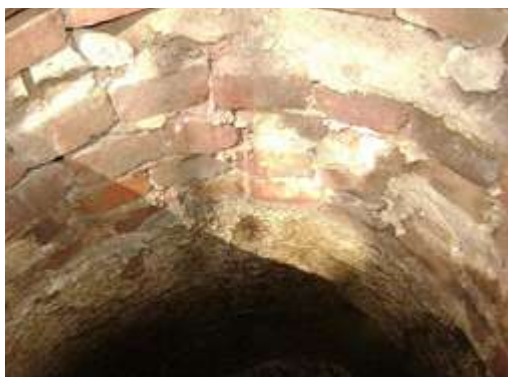
Defect 4

Infiltration: ☐ None ☒ **Joint** ☐ Cracks ☒ **Mortar** ☐ Roots ☐ Wall

Infiltration: ☐ None ☐ Joint ☐ Cracks ☒ **Mortar** ☐ Roots ☐ Wall

Infiltration of chimney and corbel.

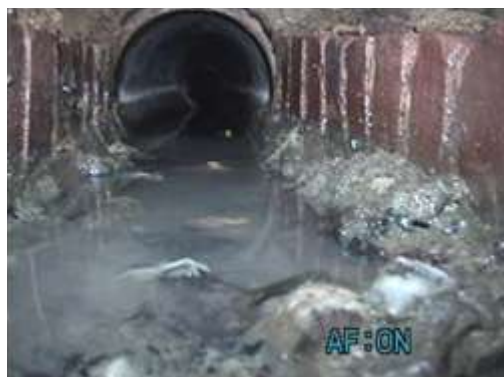
Defect 5

Condition: ☐ Sound ☐ Cracked ☐ Root Intrusion ☐ Deteriorated ☐ Leaks ☒ **Debris**

Debris in channel.

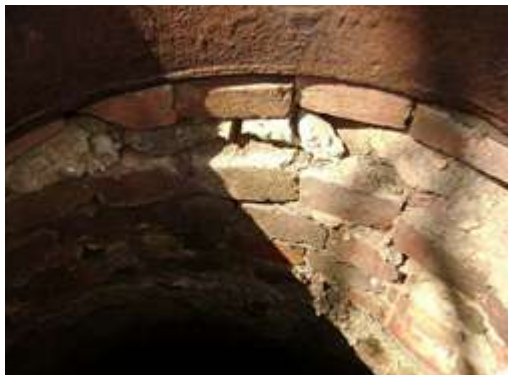
Defect 3

Loose Bricks and Deterioration around chimney/frame

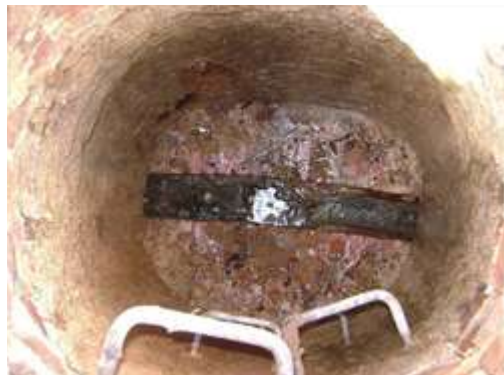
Defect 1

Condition: ☐ Sound ☐ Cracked ☐ Root Intrusion ☐ Deteriorated ☐ Leaks ☒ **Debris**

debris on bench

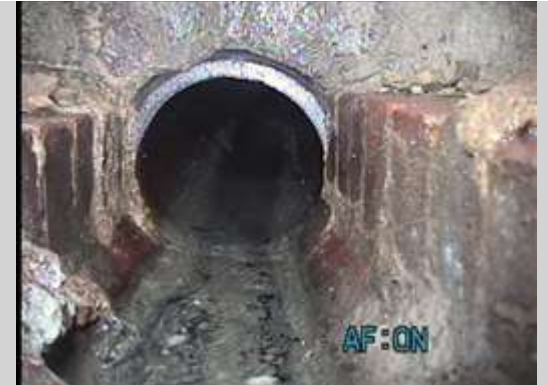
12 O'Clock Outflow

8 in. Circular Gravity Sewer
Pipe Out @ 12 O'Clock

Pipe Height: **8.4** (in.) Rod and Bar (Angled)
Pipe Material: **Clay** ☐ Pipe Lined
Invert Depth: **8.08** (ft.) Flow Characteristics: **Slow**
Deposits: ☒ None ☐ Mud ☐ Sludge ☐ Debris ☐ Grease
Silt Depth: (in.) Deposits Extent:
Infiltration: **None** Pipe Seal Cond: **Sound**

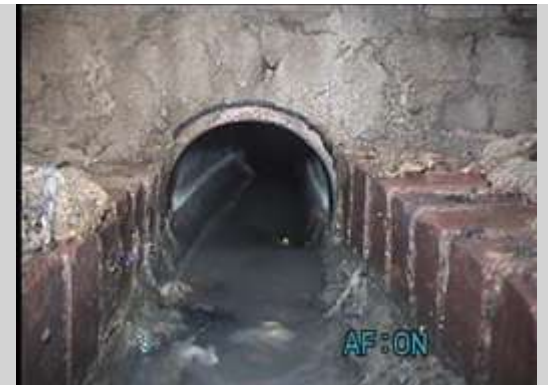
6 O'Clock Inflow

8 in. Circular Gravity Sewer
Pipe In @ 6 O'Clock

Pipe Height: **8.4** (in.) Rod and Bar (Angled)
Pipe Material: **Clay** ☐ Pipe Lined
Invert Depth: **7.92** (ft.) Flow Characteristics: **Slow**
Deposits: ☒ None ☐ Mud ☐ Sludge ☐ Debris ☐ Grease
Silt Depth: (in.) Deposits Extent:
Infiltration: **None** Pipe Seal Cond: **Sound**
